REPORT

Report Name
Kia Ceed

Type	**HATCHBACK 5D**
Make	**Kia**
Model	**Ceed**
VIN	**U5YH2511AKL079956**
First registration	**1.2.2020.**
Fuel Type	**Gas**
Engine capacity [ccm]	**998**
Power [kW]	**88**
Year of production	**2019**

Zapisnik o izvidu štete
br. 90-AK-1811/2022

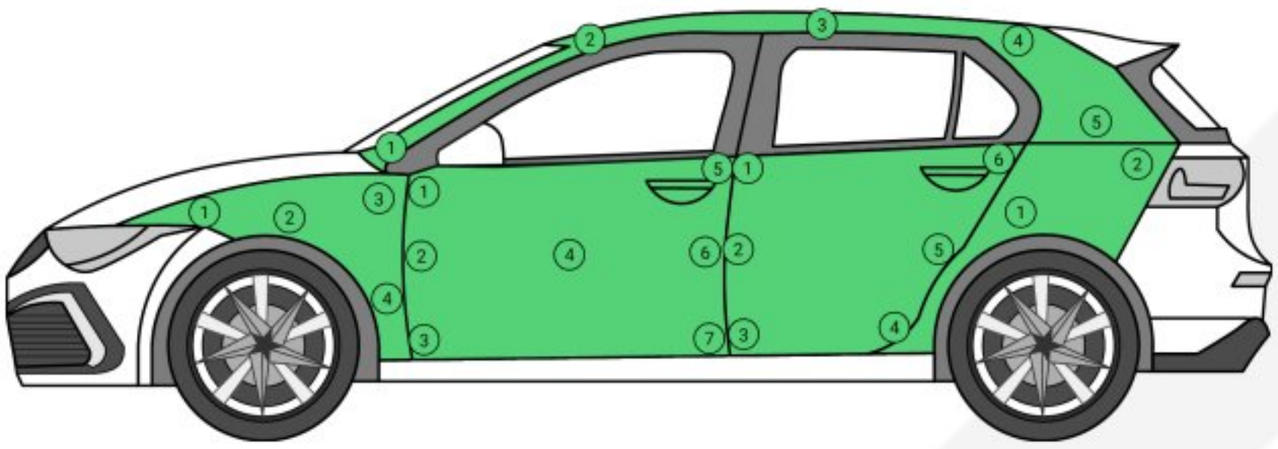
LEFT SIDE											
	Coating	Minimum	Maximum	Medium	1.	2.	3.	4.	5.	6.	7.
Left front fender/ bumper	Fe	76	102	92	76	98	90	102	-	-	-
Left front door	Fe + Zn	82	106	98	100	105	82	102	106	103	88
Left rear door	Fe	89	127	110	124	116	89	101	103	127	-
Left pillar	Fe	85	106	97	95	85	106	100	97	-	-
Left rear fender/ bumper	Fe	101	120	111	120	101	-	-	-	-	-

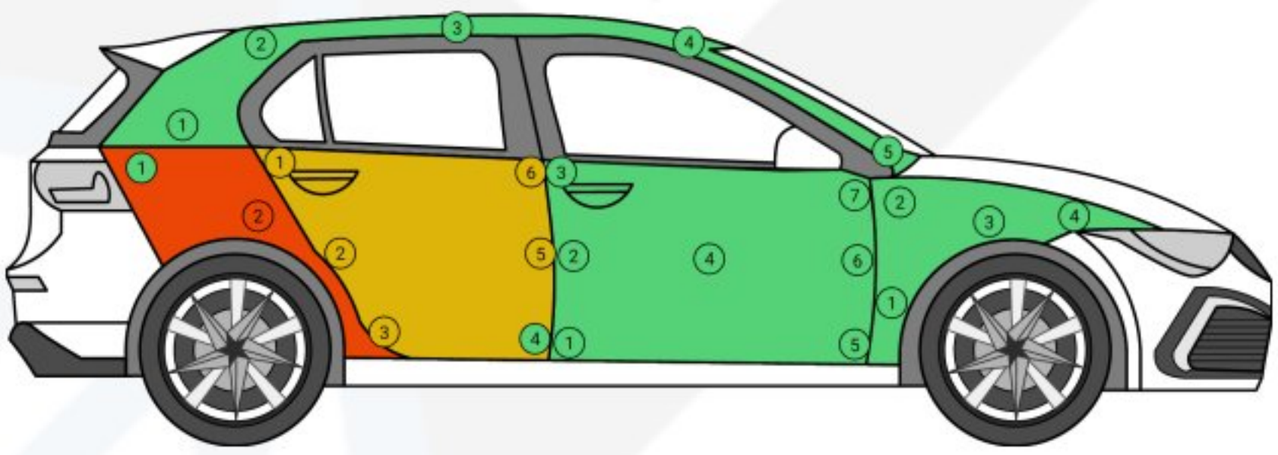
RIGHT SIDE											
	Coating	Minimum	Maximum	Medium	1.	2.	3.	4.	5.	6.	7.
Right front fender/ bumper	Fe	83	104	94	89	98	104	83	-	-	-
Right front door	Fe	77	109	99	77	106	109	106	86	106	103
Right rear door	Fe	141	255	198	196	242	255	141	183	173	-
Right pillar	Fe	89	151	114	151	139	89	89	100	-	-
Right rear fender/ bumper	Fe + Zn	148	353	251	148	353	-	-	-	-	-

VRATA ST D POPRAVAK

BOČNA STRANICA ST D POPRAVAK

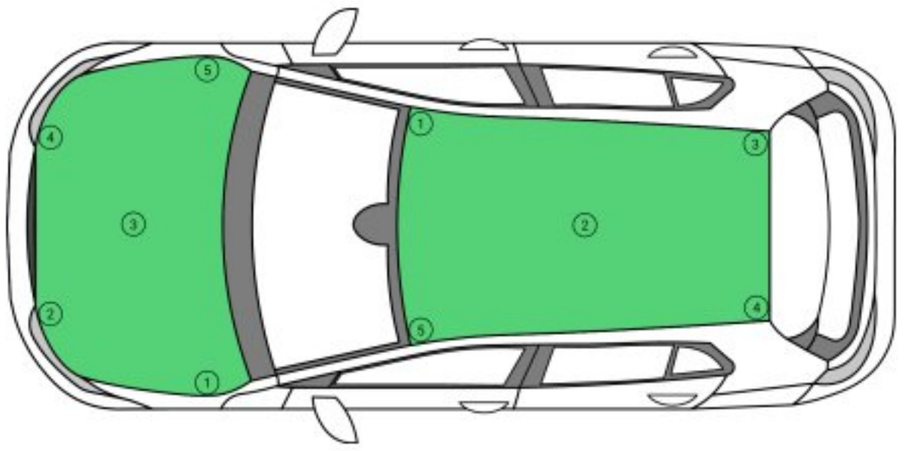
TOP											
	Coating	Minimum	Maximum	Medium	1.	2.	3.	4.	5.	6.	7.
Hood/bonnet	Fe + Zn	76	128	104	128	79	128	76	109	-	-
Roof	Fe	93	118	105	93	103	110	118	99	-	-

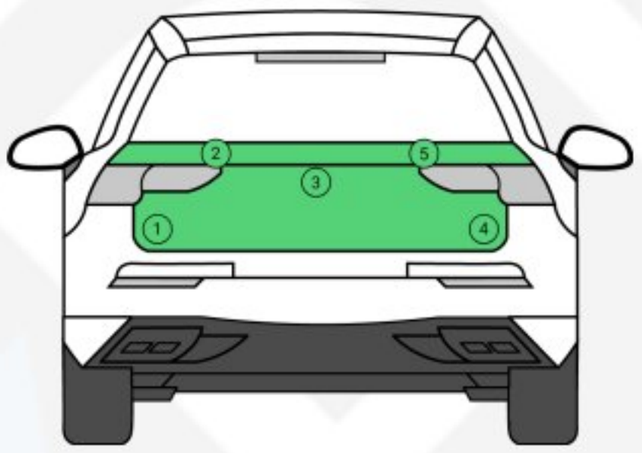
BACK											
	Coating	Minimum	Maximum	Medium	1.	2.	3.	4.	5.	6.	7.
Trunk/boot	Fe	107	131	117	107	123	131	112	111	-	-

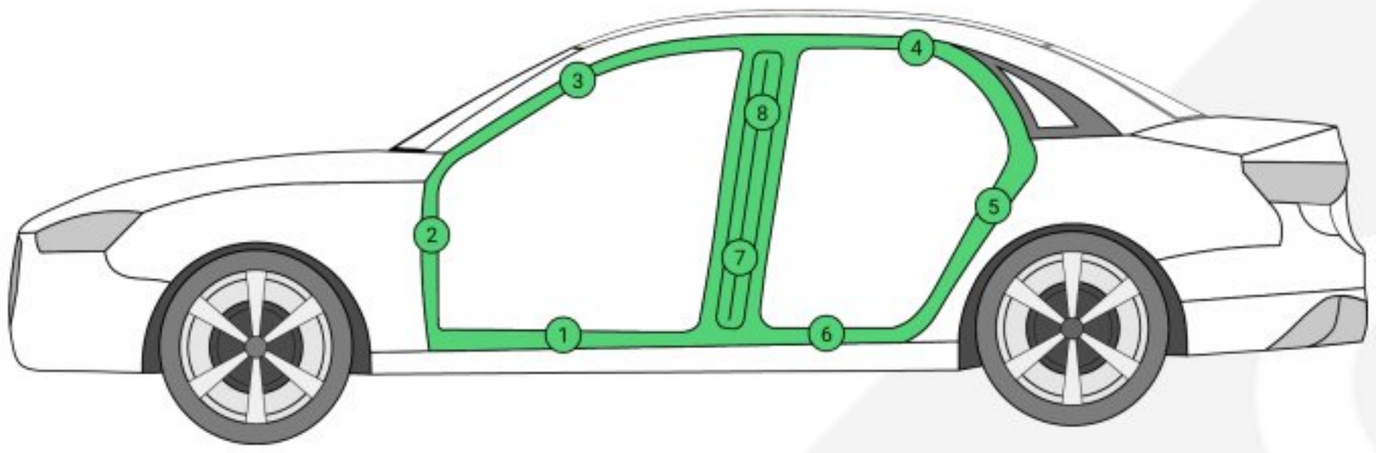
LEFT SIDE											
	Coating	Minimum	Maximum	Medium	1. 8.	2. 9.	3. 10.	4. 11.	5. 12.	6. 13.	7. 14.
Left side	Fe	41	74	56	41 74	52 -	51 -	59 -	57 -	58 -	55 -

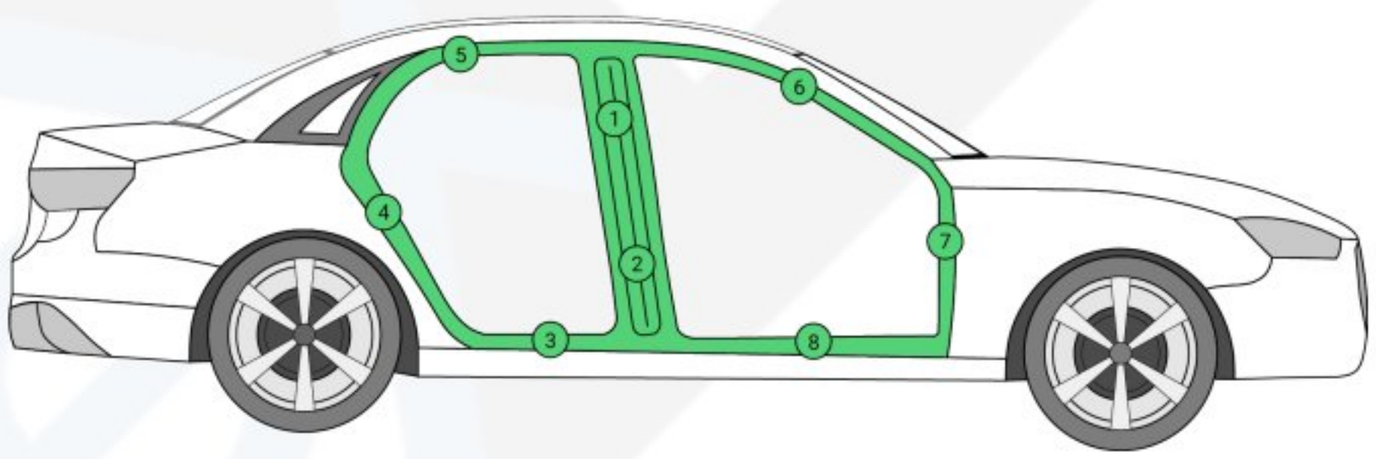
RIGHT SIDE											
	Coating	Minimum	Maximum	Medium	1. 8.	2. 9.	3. 10.	4. 11.	5. 12.	6. 13.	7. 14.
Right side	Fe	48	84	59	66 48	60 -	84 -	55 -	55 -	52 -	52 -

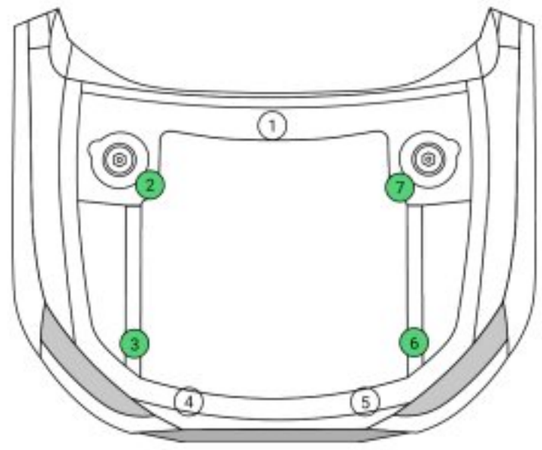
ENGINE COMPARTMENT											
	Coating	Minimum	Maximum	Medium	1.	2.	3.	4.	5.	6.	7.
Engine compartment	-	44	53	48	-	44	50	-	-	53	45

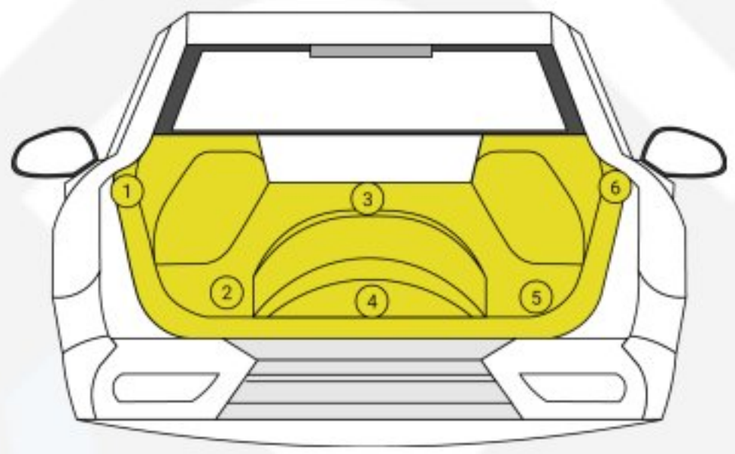
TRUNK/BOOT											
	Coating	Minimum	Maximum	Medium	1.	2.	3.	4.	5.	6.	7.
Trunk/Boot	Fe	28	39	35	35	37	39	28	35	36	-
