REPORT

Report Name
Tesla 3 LR bijela

Type	**SEDAN**
Make	**Tesla**
Model	**Model 3**
VIN	**5YJ3E7EB0MF967698**
First registration	**25.6.2021.**
Fuel Type	**Electric**
Engine capacity [ccm]	**-**
Power [kW]	**-**
Year of production	**-**

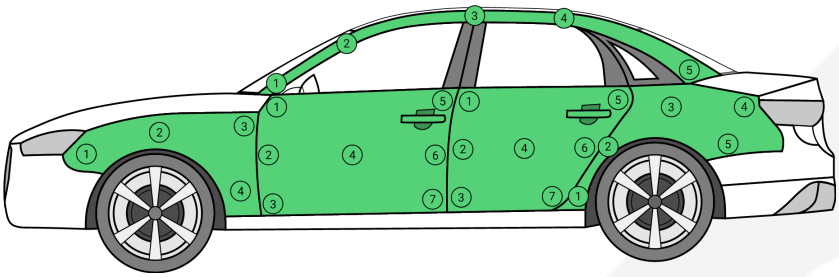
PAS: General interpretation, Body

LEFT SIDE											
	Coating	Minimum	Maximum	Medium	1.	2.	3.	4.	5.	6.	7.
Left front fender/ bumper	Fe + Zn	77	104	89	88	104	88	77	-	-	-
Left front door	Al	83	105	93	96	96	83	105	83	103	87
Left rear door	Al	73	110	92	92	104	92	110	73	80	91
Left pillar	Fe + Zn	92	129	107	104	114	129	92	98	-	-
Left rear fender/ bumper	Fe + Zn	83	116	104	83	106	107	110	116	-	-

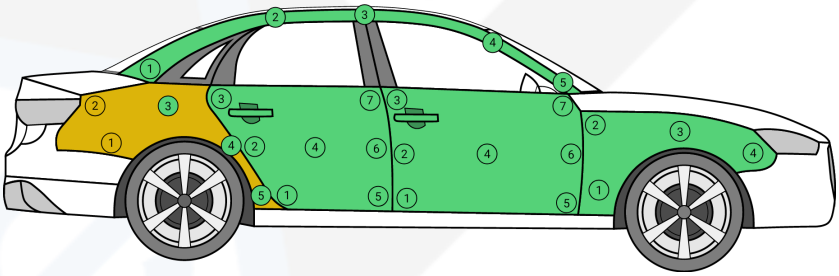
RIGHT SIDE											
	Coating	Minimum	Maximum	Medium	1.	2.	3.	4.	5.	6.	7.
Right front fender/ bumper	Fe	86	100	91	86	100	90	88	-	-	-
Right front door	Al	86	105	97	86	99	96	105	88	105	101
Right rear door	Al	81	118	94	81	82	90	105	95	118	88
Right pillar	Fe + Zn	76	128	105	100	76	128	111	108	-	-
Right rear fender/ bumper	Fe	125	200	166	200	198	162	143	125	-	-

Left rear fender/bumper	1. 83	2. 106	3. 107	4. 110	5. 116	- -	- -	- -	- -	- -	- -	- -	- -	- -
Right rear fender/ bumper	5. 125	4. 143	3. 162	2. 198	1. 200	- -	- -	- -	- -	- -	- -	- -	- -	- -
Difference	**42**	**37**	**55**	**88**	**84**									
INTERNAL MEASUREMENTS														
Left side	1. -	2. -	3. -	4. -	5. -	6. -	7. -	8. -	- -	- -	- -	- -	- -	- -
Right side	8. -	7. -	6. -	5. -	4. -	3. -	2. -	1. -	- -	- -	- -	- -	- -	- -
Difference

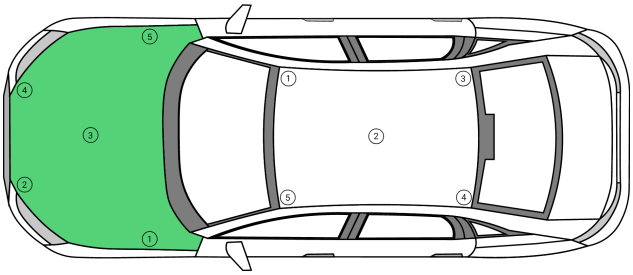
TOP											
	Coating	Minimum	Maximum	Medium	1.	2.	3.	4.	5.	6.	7.
Hood/bonnet	Al	85	129	102	99	97	129	99	85	-	-
Roof	-	-	-	-	-	-	-	-	-	-	-

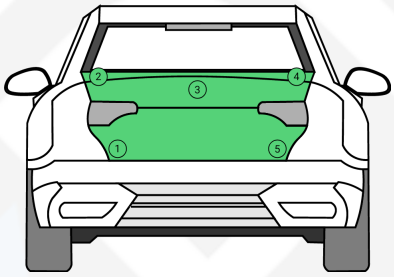
BACK											
	Coating	Minimum	Maximum	Medium	1.	2.	3.	4.	5.	6.	7.
Trunk/boot	Fe + Zn	80	97	87	80	93	81	86	97	-	-
